EMC2104 Silicon Errata and Data Sheet Clarification

TABLE 1: CHIP REVISION INFORMATION

Device ID = 1DH		
Functional Revision	Revision Number	Part Marking (Note 1)
B	01h	2104-1 Lot Number BCC
C	02h	2104-1 Lot Number CCC

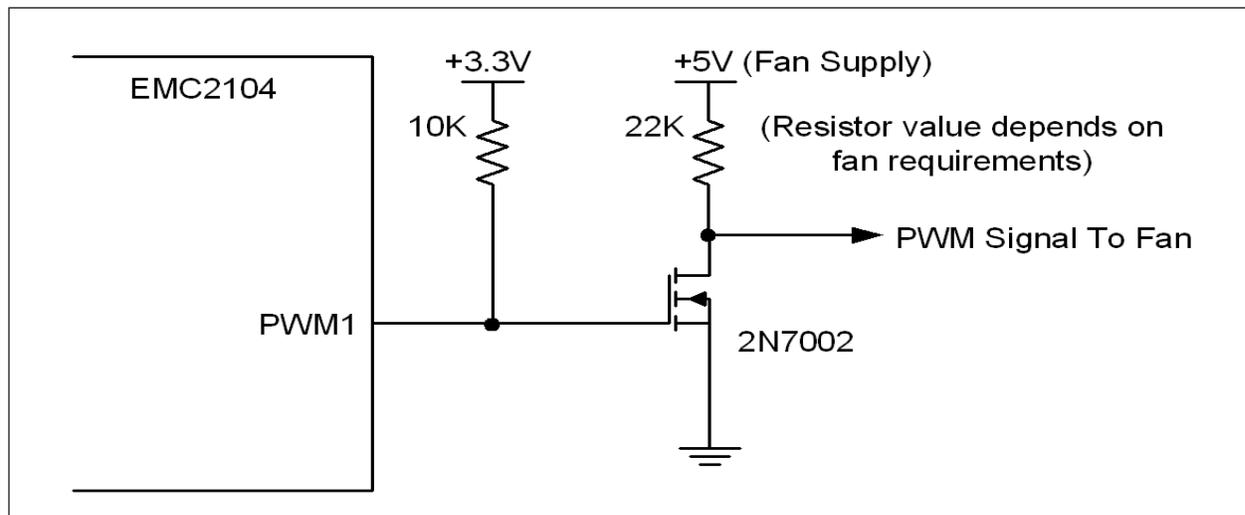
FIGURE 1: PWM DRIVE SIGNAL INVERSION

Errata 1: PWM1 Polarity Inverted

The PWM1 output is inverted so it is logic high when in the fan OFF condition.

This polarity inversion is opposite of the requirements for directly driving most 4-wire fans.

A signal inversion must be added. A typical circuit is shown in [Figure 1](#).
