# dsPIC33FJ32GS406/606/608/610 and dsPIC33FJ64GS406/606/608/610

## dsPIC33FJ32GS406/606/608/610 and dsPIC33FJ64GS406/606/608/610 Family Silicon Errata and Data Sheet Clarification

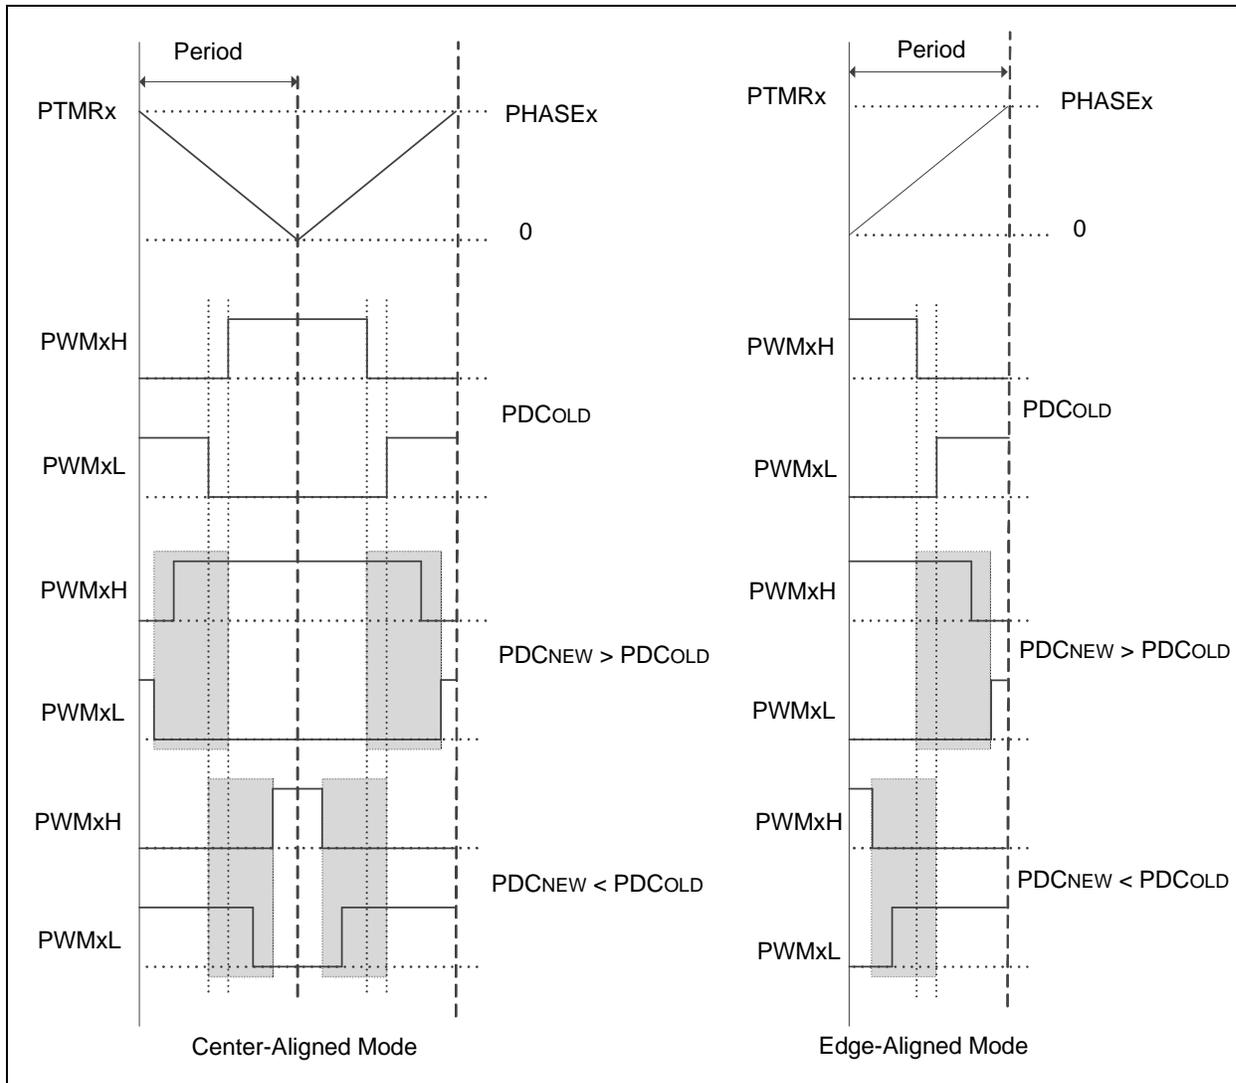
FIGURE 1: TIMING DIAGRAMS FOR CENTER-ALIGNED AND EDGE-ALIGNED MODES

The PWMx generator may not assert dead time on the edges of transitions. This has been observed when all of the following conditions are present:

In [Figure 1](#) (following page), if the duty cycle write occurred in the shaded box, then PWMxH and PWMxL will make an immediate transition without dead time.

None. However, in most applications the duty cycle update timing can be controlled using the TRIGx trigger or Special Event Trigger, such that the above mentioned conditions are avoided altogether.

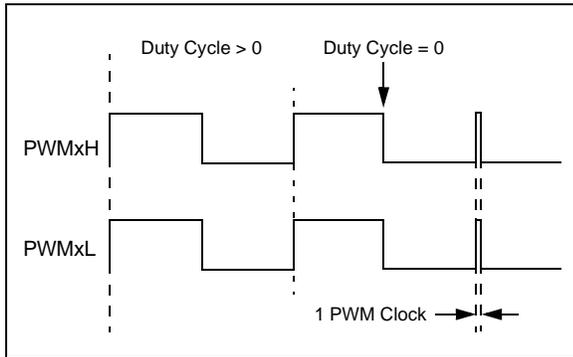
**FIGURE 2: ISSUE EXAMPLE FOR REDUNDANT OUTPUT MODE**

In Redundant Output mode (IOCONx<11:10> = 01) and Push-Pull Output mode (IOCONx<11:10> = 10), with the Immediate Update Enable bit disabled (PWMCONx<0> = 0), when the Duty Cycle register is updated from a non-zero value to zero, a glitch pulse of a width equal to 1 PWM clock will appear at the next PWM period boundary, as shown in Figure 2 (for the Redundant Output mode). The Duty Cycle register refers to the PDCx register if PWMCONx<8> = 0 or the MDC register if PWMCONx<8> = 1.

If the application requires a zero duty cycle output, there are two possible work around methods:

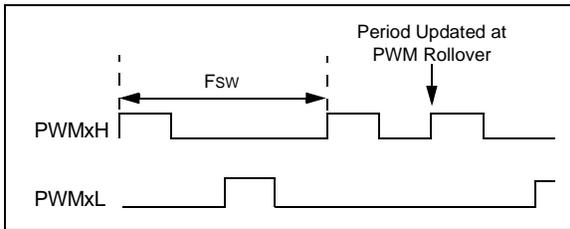
**FIGURE 3:**

When the PWM module is configured for Push-Pull mode (IOCONx<11:10> = 10) with the Enable Immediate Period Update bit enabled (PTCON <10> = 1), a write to the Period register that coincides with the period rollover event may cause the push-pull output logic to produce back-to-back pulses on the PWMx pins (Figure 3).

Ensure that the update to the PWM Period register occurs away from the PWM rollover event by setting the EIPU bit (PTCON<10> = 1). Use either the PWM Special Event Trigger (SEVTCMP) or the PWM Primary Trigger (TRIGx) to generate a PWM Interrupt Service Routine (ISR) near the start of the PWM cycle. This ISR will ensure that period writes do not occur near the PWM period rollover event.

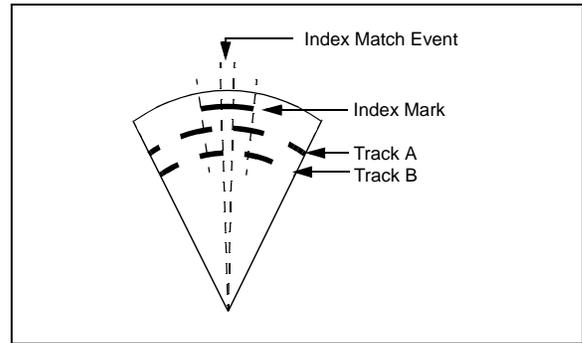
**FIGURE 4: ENCODER IN THE SECTOR AROUND THE INDEX MARK**

This issue is most likely to be seen in specific motor applications using a rotation encoder with an ungated index pulse, operating at near zero speed and/or in the presence of mechanical vibration. In these applications, the encoder may change direction and incrementally rock back and forth. If this happens with the encoder positioned in the vicinity of its index mark, the module will detect the first index match event as the encoder rotates into the index match event area, but not subsequent events if it drifts into and out of that position but stays within the index mark area (Figure 4). If the encoder count increments or decrements in only one direction, the index match will only occur once.

As a result of this, the value of POSxCNT may leave its expected range of 0 to maximum count (defined as the number of encoder pulses per revolution, minus 1), resulting in erroneous reporting of the rotor's position.

None.

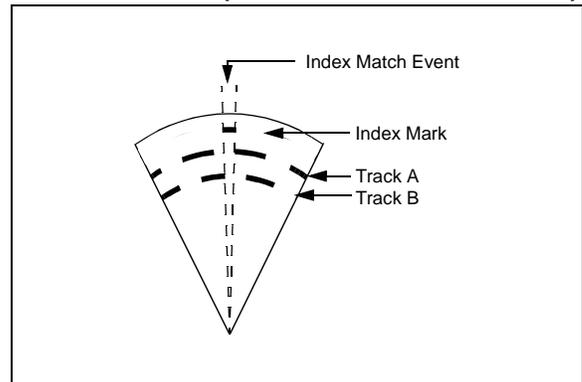
**FIGURE 5: ENCODER IN THE SECTOR AROUND THE INDEX MARK (ONE COUNT WIDTH INDEX)**

This issue is not seen when the encoder uses an index mark that is one encoder count in width (Figure 5).
