**STM8S003xx, STM8S103xx and STM8S903xx
device limitations**

Silicon identification

This errata sheet applies to the STMicroelectronics STM8S003xx, STM8S103xx and STM8S903xx devices.

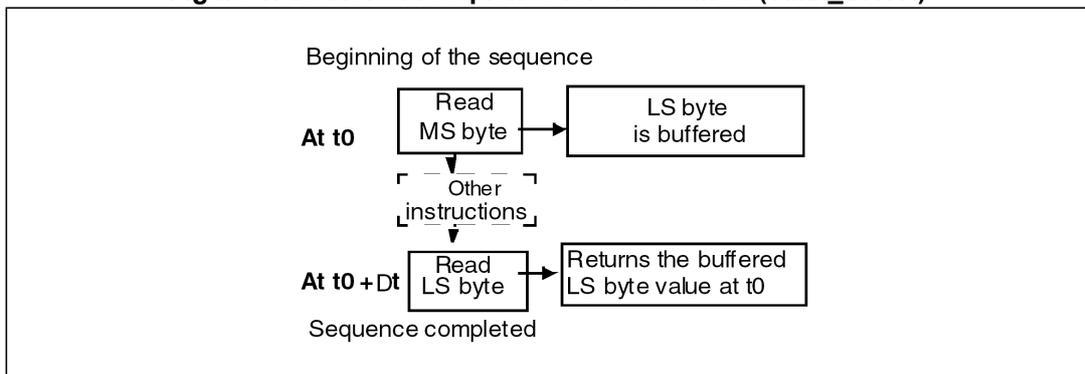
Figure 1. 16-bit read sequence for the counter (TIMx_CNTR)

An 8-bit buffer is implemented for reading the 16-bit counter registers. Software must read the MS byte first, after which the LS byte value is buffered automatically (see *Figure 1*). This buffered value remains unchanged until the 16-bit read sequence is completed.

When any multi-cycle instruction precedes the read of the LSB, the content of the buffer is lost and the second read returns the immediate content of the counter directly.

Do not use multi-cycle instructions before reading the LSB.
