## STM8S007xx and STM8S20xxx device limitations

This errata sheet applies to revisions X, Y/6, V and W/7 of the STMicroelectronics STM8S007xx and STM8S20xxx products.

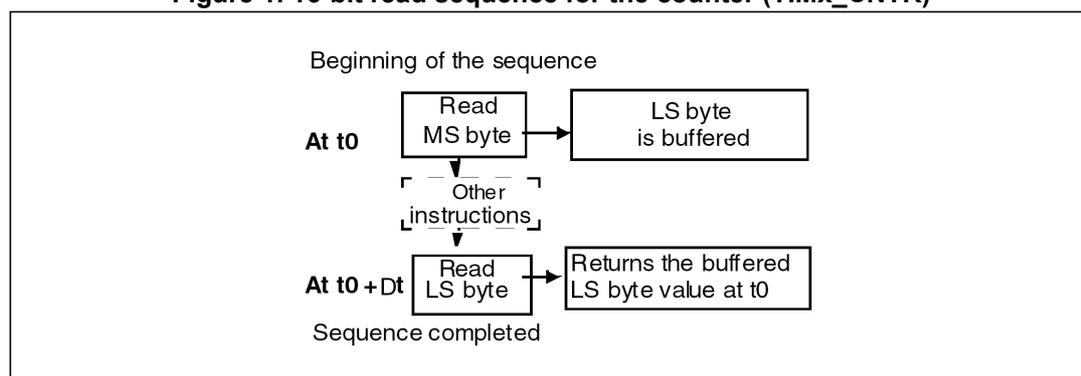
**Figure 1. 16-bit read sequence for the counter (TIMx\_CNTR)**

An 8-bit buffer is implemented for reading the 16-bit counter registers. Software must read the MS byte first, after which the LS byte value is buffered automatically (see *Figure 1*). This buffered value remains unchanged until the 16-bit read sequence is completed.

When any multi-cycle instruction precedes the read of the LSB, the content of the buffer is lost and the second read returns the immediate content of the counter directly.

Do not use multi-cycle instructions before reading the LSB.
