## PIC16(L)F1934/1936/1937 Family Silicon Errata and Data Sheet Clarification

The PIC16(L)F1934/1936/1937 family devices that you have received conform functionally to the current Device Data Sheet (DS41364E), except for the anomalies described in this document.

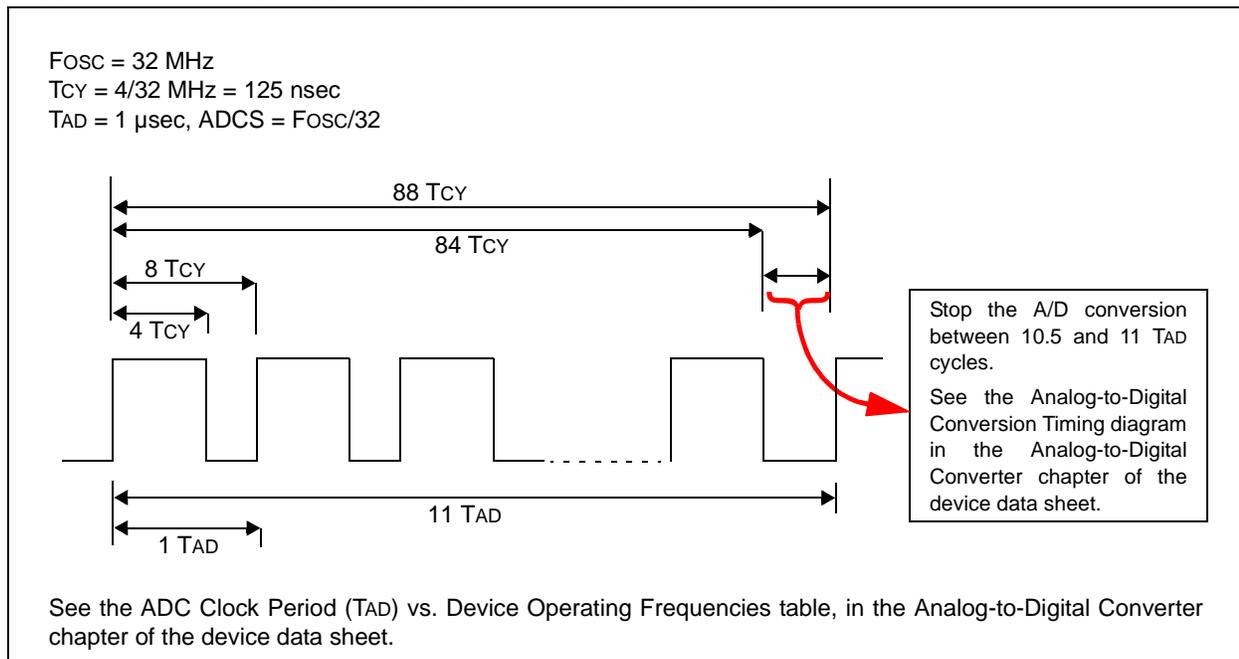
**FIGURE 1: INSTRUCTION CYCLE DELAY CALCULATION EXAMPLE**

An ADC conversion may not complete under these conditions:

1. When FOSC is greater than 8 MHz and it is the clock source used for the ADC converter.
2. The ADC is operating from its dedicated internal FRC oscillator and the device is not in Sleep mode (any FOSC frequency).

When this occurs, the ADC Interrupt Flag (ADIF) does not get set, the GO/DONE bit does not get cleared, and the conversion result does not get loaded into the ADRESH and ADRESL result registers.

In [Figure 1](#), 88 instruction cycles (TCY) will be required to complete the full conversion. Each TAD cycle consists of 8 TCY periods. A fixed delay is

provided to stop the A/D conversion after 86 instruction cycles and terminate the conversion at the correct time as shown in the figure above.

Method 3: This method is provided if the application cannot use Sleep mode and requires continuous operation at frequencies above 8 MHz. This method requires early termination of an ADC conversion. Provide a fixed time delay in software to stop the A-to-D conversion manually, after all 10 bits are converted, but before the conversion would complete automatically. The conversion is stopped by clearing the GO/DONE bit in software. The GO/DONE bit must be cleared during the last 1/2 TAD cycle, before the conversion would have completed automatically. Refer to [Figure 1](#) for details.

**Note:** The exact delay time will depend on the TAD divisor (ADCS) selection. The Tcy counts shown in the timing diagram above apply to this example only. Refer to [Table 3](#) for the required delay counts for other configurations.
