PIC18F87J50 Family Silicon Errata and Data Sheet Clarification

The PIC18F87J50 family devices that you have received conform functionally to the current Device Data Sheet (DS39775C), except for the anomalies described in this document.

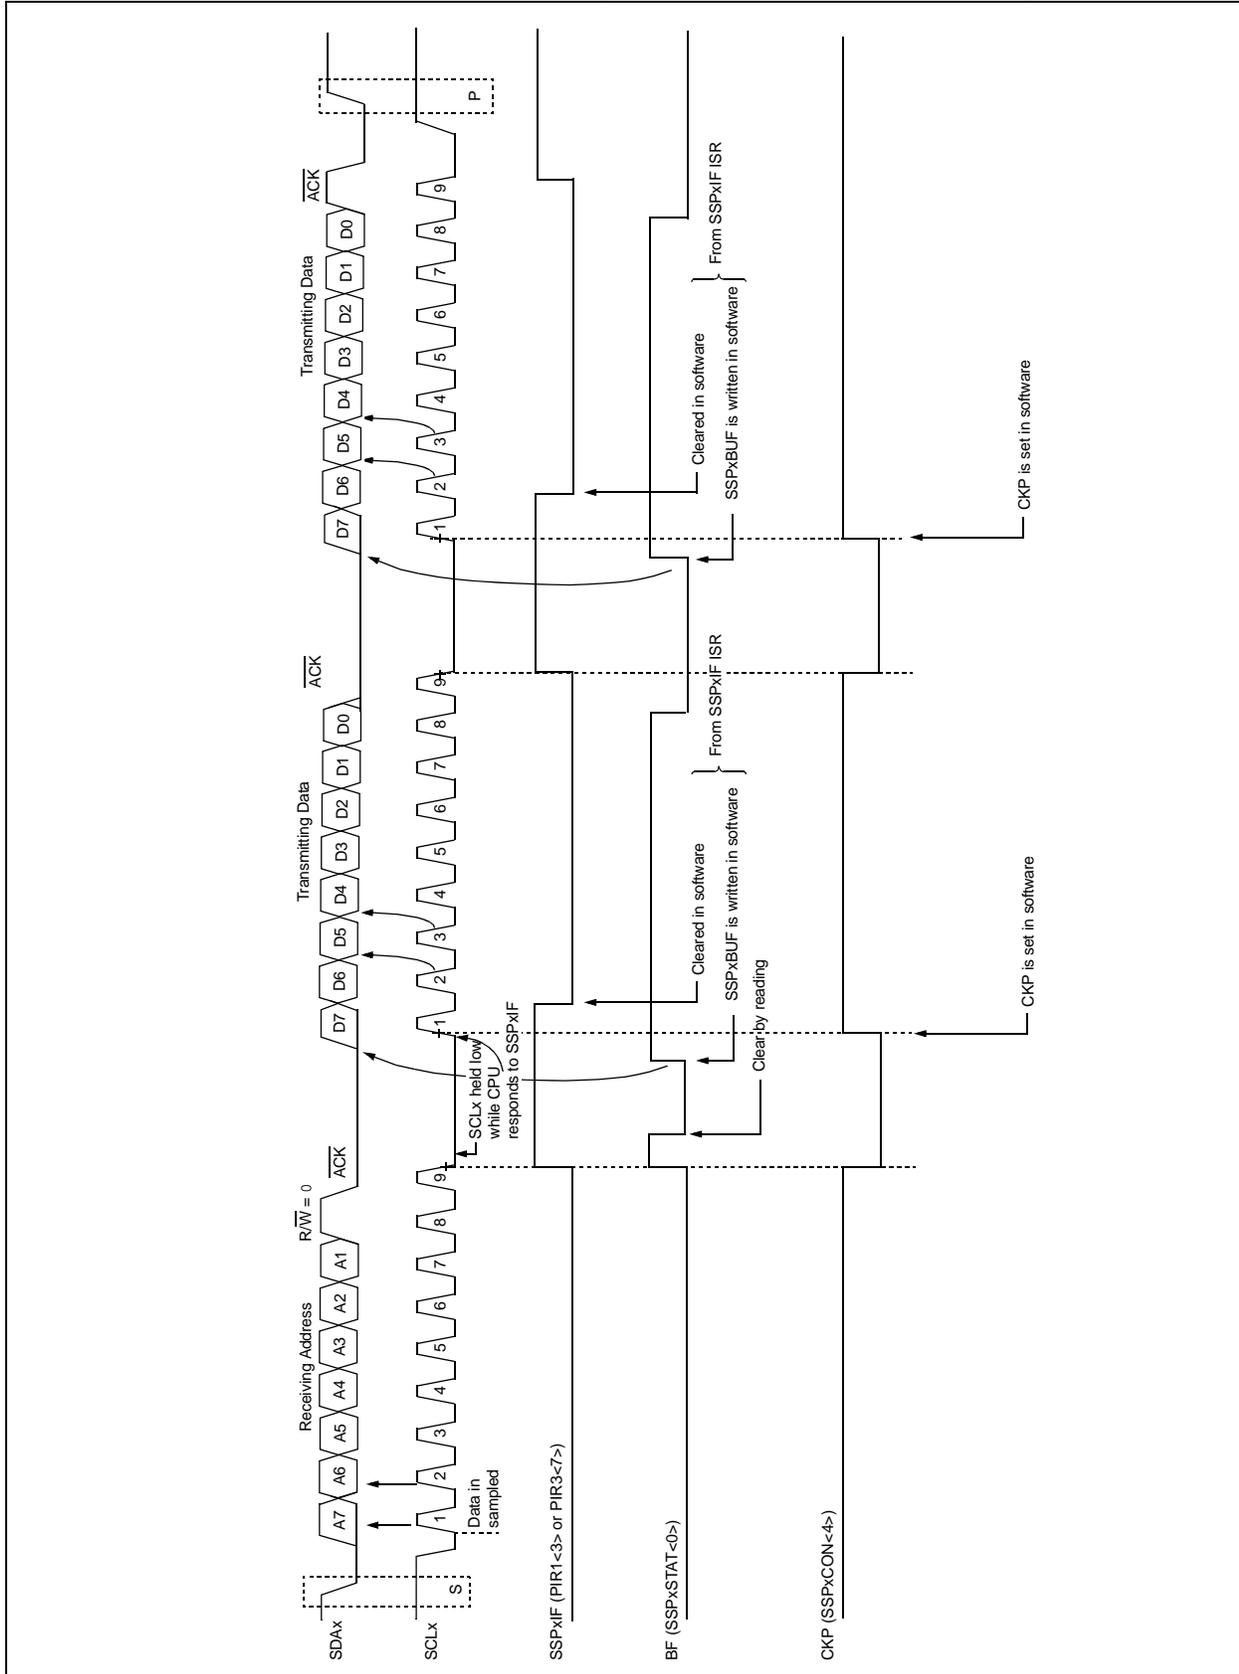
FIGURE 19-10: I²C™ SLAVE MODE TIMING (TRANSMISSION, 7-BIT ADDRESS)

6. Module: Figure 19-10: I²C™ Slave Mode Timing (Transmission, 7-Bit Address)

On page 252, the figure is replaced with the new timing diagram provided in [Figure 19-10](#).
