PIC18F2410/2510/4410/4510 Rev. A1 Silicon Errata

The PIC18F2410/2510/4410/4510 Rev. A1 parts you have received conform functionally to the Device Data Sheet (DS39636D), except for the anomalies described below. Any Data Sheet Clarification issues related to the PIC18F2410/2510/4410/4510 will be reported in a separate Data Sheet errata. Please check the Microchip web site for any existing issues.

The following silicon errata apply only to PIC18F2410/2510/4410/4510 devices with these Device/Revision IDs:

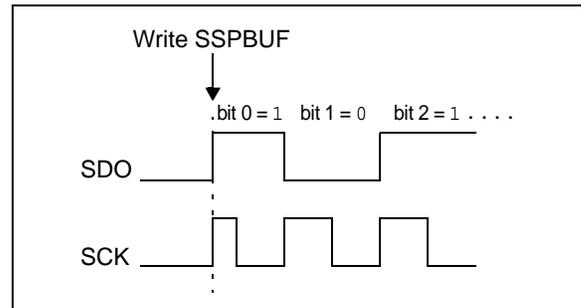
When the SPI is using Timer2/2 as the clock source, a shorter than expected SCK pulse may occur on the first bit of the transmitted/received data (Figure 1).

FIGURE 1: SCK PULSE VARIATION USING TIMER2/2

To avoid producing the short pulse, turn off Timer2 and clear the TMR2 register, load the SSPBUF with the data to transmit and then turn Timer2 back on. Refer to Example 6 for sample code.
