## dsPIC30F6011/6012/6013/6014 Rev. B1 Silicon Errata

### dsPIC30F6011, dsPIC30F6012, dsPIC30F6013, dsPIC30F6014 (Rev. B1) Silicon Errata

The errata in this document apply to all devices marked with year and week codes, "04" and "06", respectively, or later.

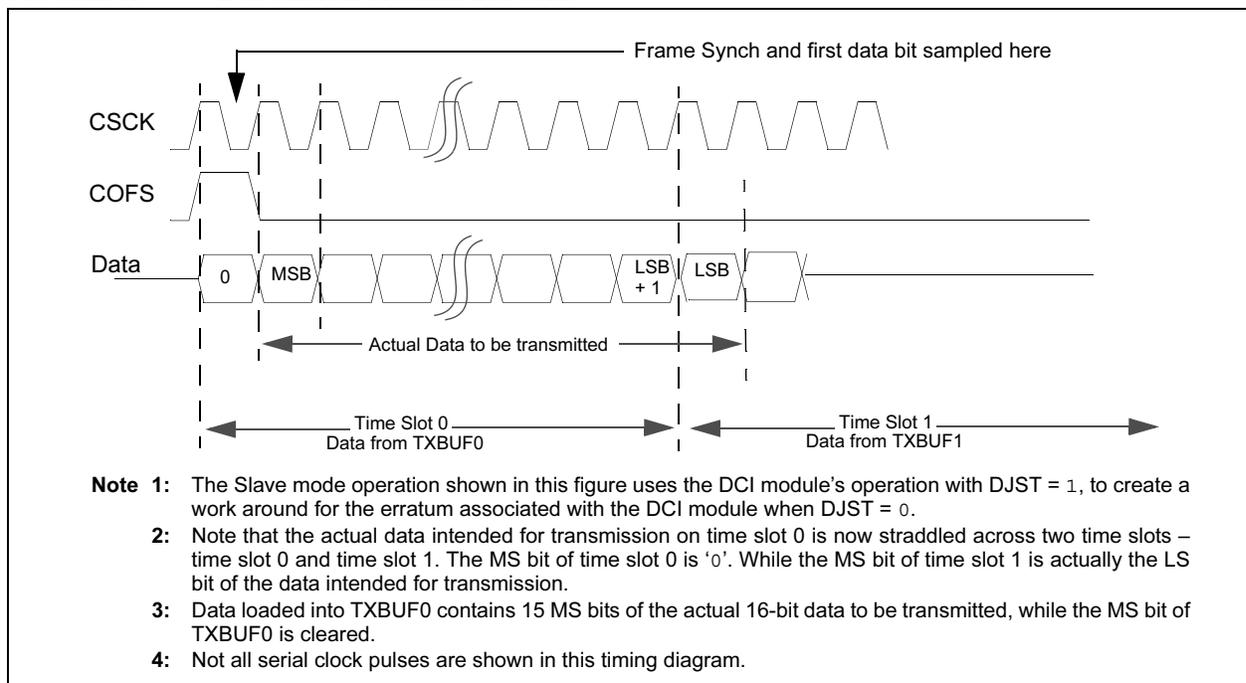
**FIGURE 1: DCI SLAVE WORK AROUND**

The Data Converter Interface (DCI) module does not function correctly in Slave mode when the following conditions are true:

- The DCI module is configured to transmit/receive one serial clock (bit clock) after the frame synchronization pulse,
$$DJST(DCICON1<5>) = 0.$$
- The frame length chosen is longer than 1 word,
$$COFSG(DCICON2<8:5>) > 0000.$$

The following work around may be applied to enable DCI communication in Slave mode when it is configured to transmit one serial clock after the frame synchronization pulse is received in a multi-word frame:

1. Set the DJST bit to '1'.
2. Enable an additional time slot immediately following each time slot intended for communication.
3. Enable an additional transmit/receive buffer word (modify COFSG bits) or an additional bit per word (modify WS) for each time slot intended for communication.
4. Shift the data word by 1 bit to the right and load the transmit buffer word(s), such that the LS Bit of the original data word to be transmitted is loaded into the additionally enabled bit of the transmit buffer register, TXBUF<sub>n</sub>, or the MS bit of the additionally enabled transmit buffer, TXBUF<sub>n+1</sub>.

An example of loading the DCI Transmit buffers for the configuration above is shown in Example 13. A timing diagram in Figure 1 illustrates the various signals for this example. A similar rule may be applied to reading the received data from the RXBUF<sub>n</sub> SFRs.
