PIC16(L)F1938/1939 Silicon Errata and Data Sheet Clarification

The PIC16(L)F1938/1939 family devices that you have received conform functionally to the current Device Data Sheet (DS40001574C), except for the anomalies described in this document.

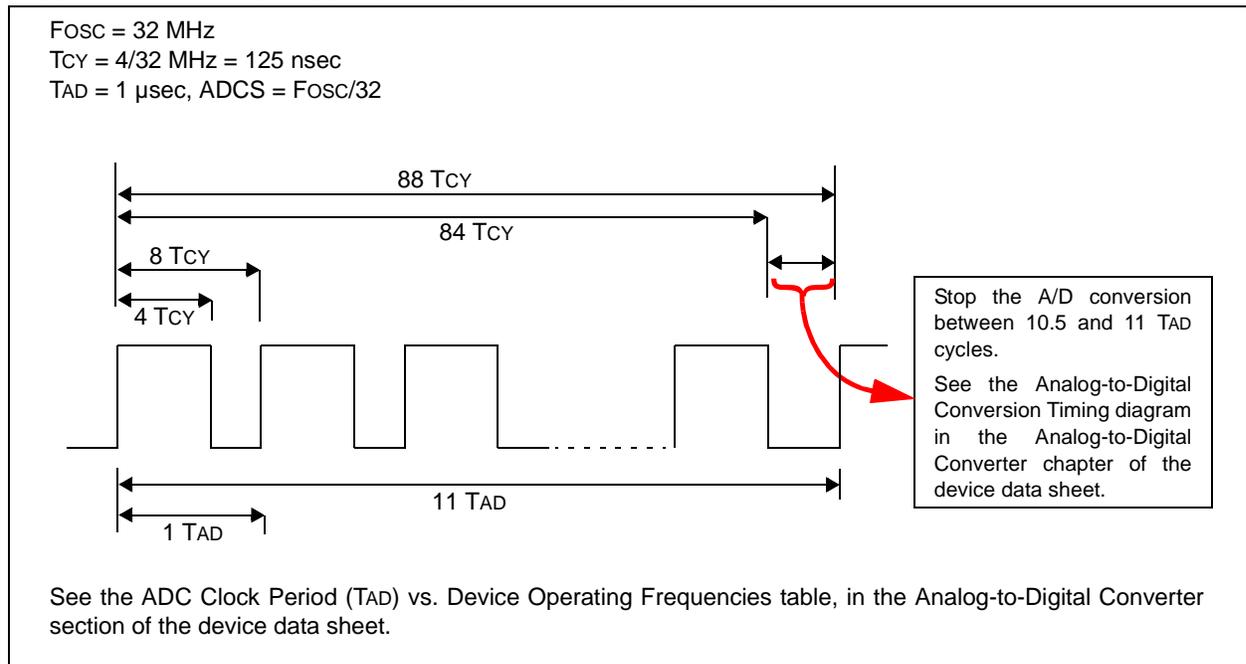
FIGURE 1: INSTRUCTION CYCLE DELAY CALCULATION EXAMPLE

In [Figure 1](#), 88 instruction cycles (T_{cy}) will be required to complete the full conversion. Each TAD cycle consists of 8 T_{cy} periods. A fixed delay is provided to stop the A/D conversion after 86 instruction cycles and terminate the conversion at the correct time as shown in the figure above.

Note: The exact delay time will depend on the TAD divisor (ADCS) selection. The T_{cy} counts shown in the timing diagram above apply to this example only. Refer to [Table 3](#) for the required delay counts for other configurations.

Method 3: This method is provided if the application cannot use Sleep mode and requires continuous operation at frequencies above 8 MHz. This method requires early termination of an ADC conversion. Provide a fixed time delay in software to stop the A-to-D conversion manually, after all 10 bits are converted, but before the conversion would complete automatically. The conversion is stopped by clearing the GO/DONE bit in software. The GO/DONE bit must be cleared during the last 1/2 TAD cycle, before the conversion would have completed automatically. Refer to Figure 1 for details.

```
BSF    ADCON0, ADGO    ; Start ADC conversion
                        ; Provide 86
                        ; instruction cycle
                        ; delay here
BCF    ADCON0, ADGO    ; Terminate the
                        ; conversion manually
MOVF   ADRESH, W       ; Read conversion
                        ; result
```
