Device limitations for STM8AF62xx automotive MCUs featuring up to 8 Kbytes of Flash program memory

This errata sheet applies to the STMicroelectronics STM8AF6213 and STM8AF6223/26 devices.

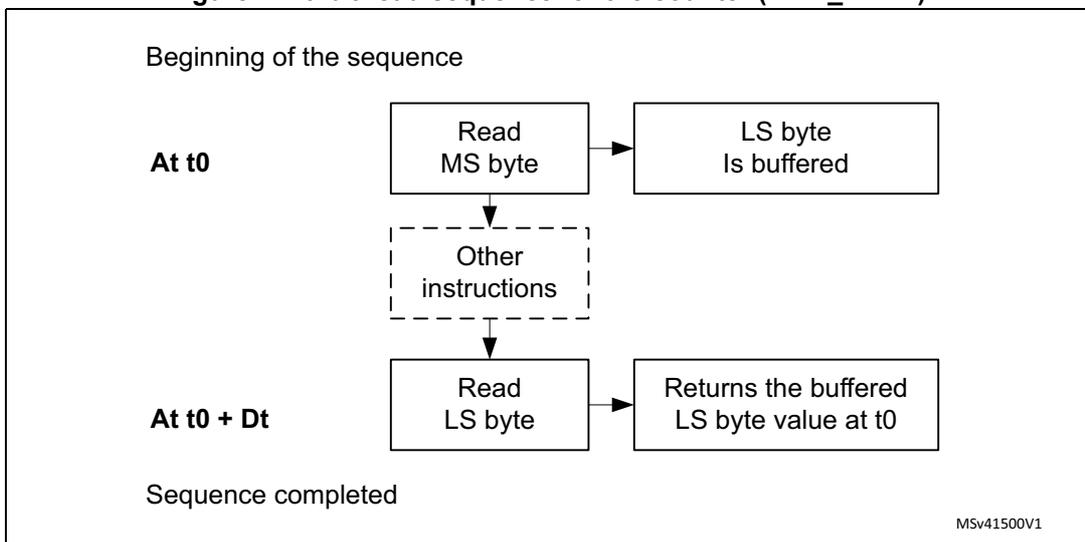
Figure 1. 16-bit read sequence for the counter (TIMx_CNTR)

An 8-bit buffer is implemented for reading the 16-bit counter registers. Software must read the MS byte first, after which the LS byte value is buffered automatically (see [Figure 1](#)). This buffered value remains unchanged until the 16-bit read sequence is completed.

When any multi-cycle instruction precedes the read of the LSB, the content of the buffer is lost and the second read returns the immediate content of the counter directly.

Do not use multi-cycle instructions before reading the LSB.
