PIC18F87J10 Family Rev. A5/A6 Silicon Errata

The PIC18F87J10 family parts you have received conform functionally to the Device Data Sheet (DS39663F), except for the anomalies described below. Any Data Sheet Clarification issues related to the PIC18F87J10 family will be reported in a separate Data Sheet errata. Please check the Microchip web site for any existing issues.

The following silicon errata apply only to PIC18F87J10 family devices with these Device/Revision IDs:

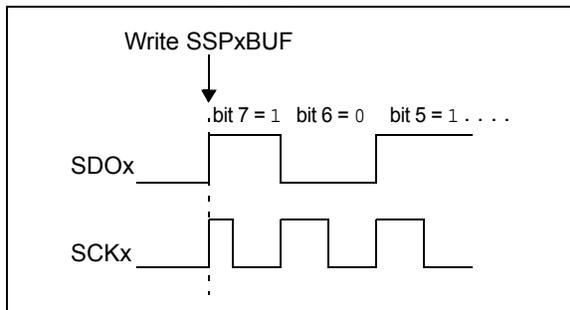
FIGURE 1: SCKx PULSE VARIATION USING TIMER2/2

8. Module: Master Synchronous Serial Port (MSSP)

When the SPI is using Timer2/2 as the clock source, a shorter than expected SCKx pulse may occur on the first bit of the transmitted/received data (see Figure 1).

Work around

To avoid producing the short pulse:

1. Turn off Timer2.
2. Clear the TMR2 register.
3. Load the SSPxBUF with the data to be transmitted.
4. Turn Timer2 back on.
