dsPIC33EPXXGS50X Family Silicon Errata and Data Sheet Clarification

The dsPIC33EPXXGS50X family devices that you have received conform functionally to the current Device Data Sheet (DS70005127C), except for the anomalies described in this document.

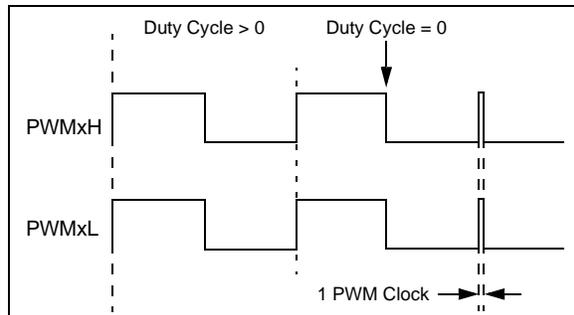
FIGURE 1: EXAMPLE FOR REDUNDANT OUTPUT MODE

In the Redundant Output mode (IOCONx<11:10> = 0b01) and Push-Pull Output mode (IOCONx<11:10> = 0b10), with the Immediate Update Enable bit disabled (PWMCONx<0> = 0), when the Duty Cycle register is updated from a non-zero value to zero, a glitch pulse of a width equal to 1 PWM clock will appear at the next PWM period boundary, as shown in Figure 1 (for the Redundant Output mode). The Duty Cycle register refers to the PDCx register if PWMCONx<8> = 0 or the MDC register if PWMCONx<8> = 1.

If the application requires a zero duty cycle output, there are two possible work around methods:

1. Use the PWM override feature to override the PWM output to a low state instead of writing to the Duty Cycle register. In order to switch back to a non-zero duty cycle output, turn off the PWM override. The override-on and override-off events must be timed close to the PWM period boundary if the IOCONx register has been configured with IOCONx<0> = 0 (i.e., output overrides through the OVDDAT<1:0> bits occur on the next CPU clock boundary).
2. Enable the Immediate Update Enable bit (PWMCONx<0> = 1) while configuring the PWMx module (i.e., before enabling the PWMx module, PTCON<15> = 1). With the Immediate Update enabled, writes to the Duty Cycle register can have an immediate effect on the PWM output. Therefore, the duty cycle write operations must be timed close to the PWM period boundary in order to avoid distortions in the PWM output.

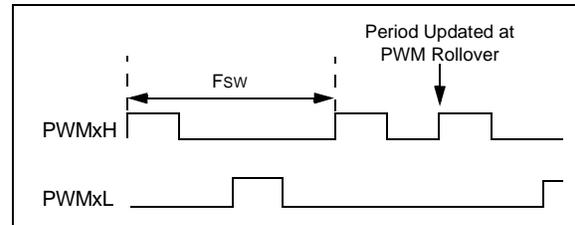
FIGURE 2:

When the PWM module is configured for Push-Pull mode (IOCONx<11:10> = 0b10) with the Enable Immediate Period Update bit enabled (PTCON <10> = 1), a write to the Period register that coincides with the period rollover event may cause the push-pull output logic to produce back-to-back pulses on the PWMx pins (Figure 2).

Ensure that the update to the PWM Period register occurs away from the PWM rollover event by setting the EIPU bit (PTCON<10> = 1). Use either the PWM Special Event Trigger (SEVTCMP) or the PWM Primary Trigger (TRIGx) to generate a PWM Interrupt Service Routine (ISR) near the start of the PWM cycle. This ISR will ensure that period writes do not occur near the PWM period rollover event.

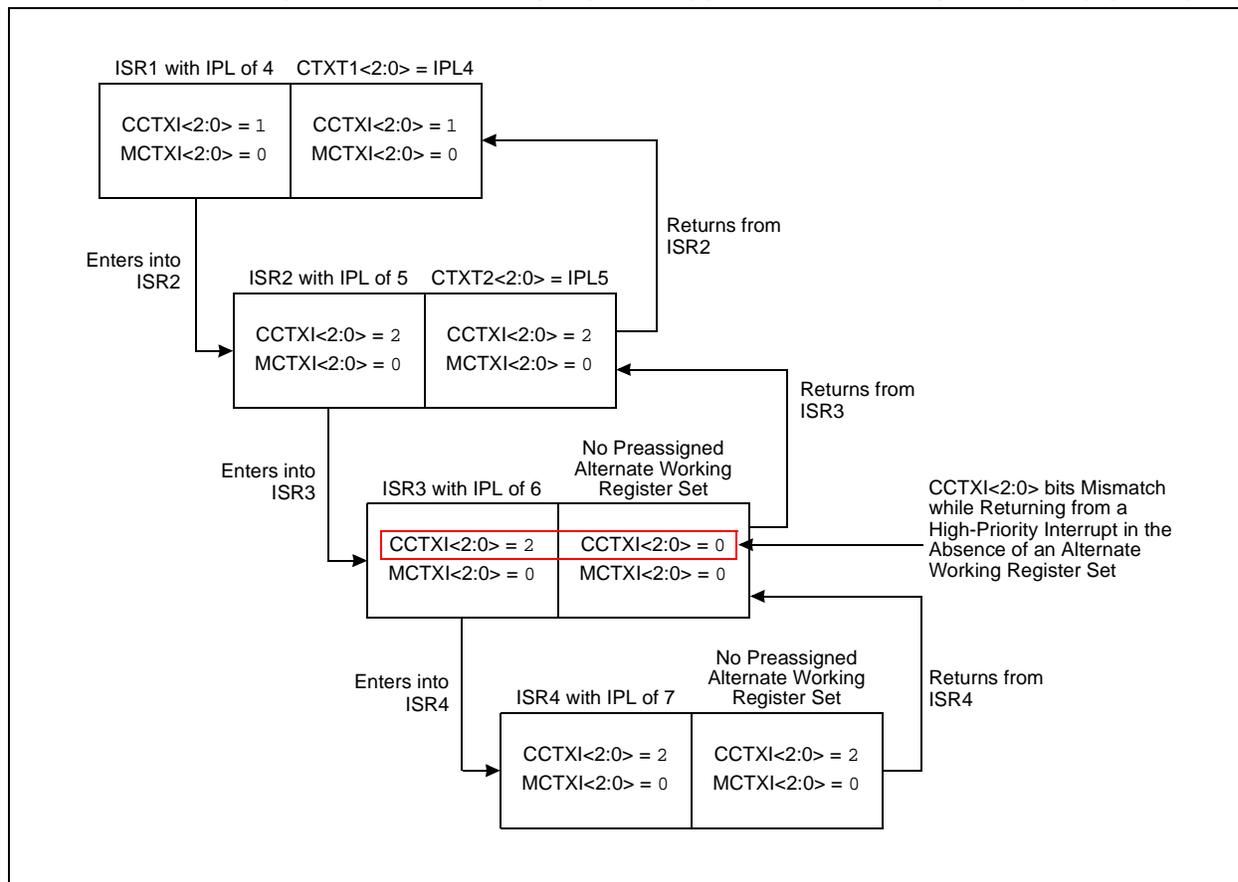
FIGURE 3: MISMATCH OF WORKING REGISTER SET WHEN NESTING MORE THAN ONE INTERRUPT WITHIN INTERRUPTS THAT USE ALTERNATE WORKING REGISTER SETS

Issue and work around are illustrated in [Figure 3](#) and [Figure 4](#), respectively. The figures show the status bits, `CCTXI<2:0>` and `MCTXI<2:0>`, after entering into an ISR from a lower priority ISR (left pane), and after returning to the same ISR from a higher priority ISR (right pane).
