# PIC16(L)F1946/1947

## PIC16(L)F1946/1947 Family Silicon Errata and Data Sheet Clarification

The PIC16(L)F1946/1947 family devices that you have received conform functionally to the current Device Data Sheet (DS41414D), except for the anomalies described in this document.

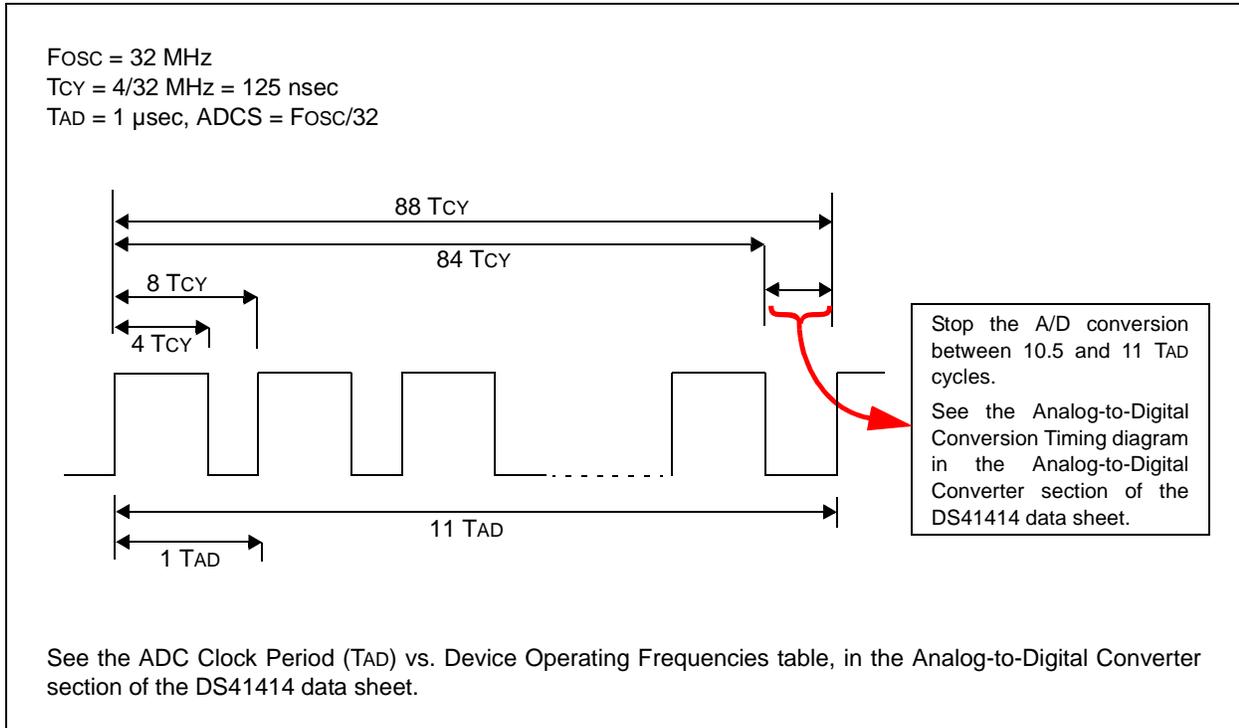
**FIGURE 1: INSTRUCTION CYCLE DELAY CALCULATION EXAMPLE**

Under certain device operating conditions, the ADC conversion may not complete properly. When this occurs, the ADC Interrupt Flag (ADIF) does not get set, the  $\overline{\text{ADGO/DONE}}$  bit does not get cleared and the conversion result does not get loaded into the ADRESH and ADRESL result registers.

In Figure 1, 88 instruction cycles (TCY) will be required to complete the full conversion. Each TAD cycle consists of eight TCY periods. A fixed delay is provided to stop the A/D conversion after 86 instruction cycles and terminate the conversion at the correct time as shown in the figure above.

**Note:** The exact delay time will depend on the choice of FOSC and the TAD divisor (ADCS) selection. The TCY counts shown in the timing diagram above apply to this example only. Refer to Table 3 for the required delay counts for other configurations.

Method 2: Provide a fixed delay in software to stop the A-to-D conversion manually, after all ten bits are converted, but before the conversion would complete automatically. The conversion is stopped by clearing the  $\overline{\text{GO/DONE}}$  bit in software. The  $\overline{\text{GO/DONE}}$  bit must be cleared during the last  $\frac{1}{2}$  TAD cycle, before the conversion would have completed automatically. Refer to [Figure 1](#) for details.

**EXAMPLE 1: CODE EXAMPLE OF INSTRUCTION CYCLE DELAY**

```
BSF   ADCON0, ADGO ; Start ADC conversion
      ; Provide 86
      ; instruction cycle
      ; delay here
BCF   ADCON0, ADGO ; Terminate the
      ; conversion manually
MOVF  ADRESH, W    ; Read conversion
      ; result
```
