## PIC24FJ128GA310 Family Silicon Errata and Data Sheet Clarification

The PIC24FJ128GA310 family devices that you have received conform functionally to the current Device Data Sheet (DS30009996G), except for the anomalies described in this document.

### 64-Lead Plastic Quad Flat, No Lead Package (MR) – 9x9x0.9 mm Body with 5.40 x 5.40 Exposed Pad [QFN]

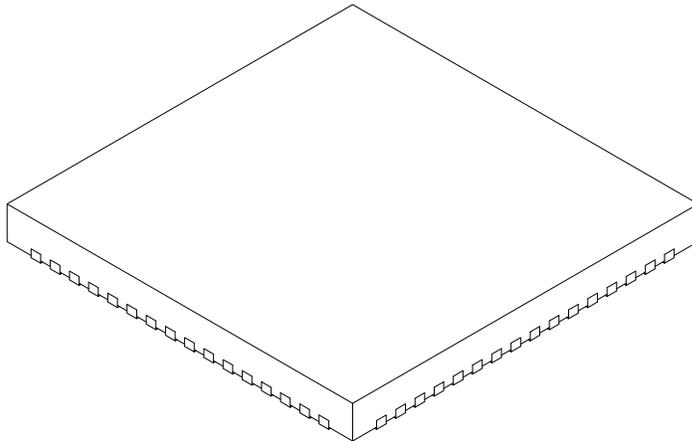
Microchip Technology Drawing C04-154A Sheet 2 of 2

## 64-Lead Plastic Quad Flat, No Lead Package (MR) – 9x9x0.9 mm Body with 5.40 x 5.40 Exposed Pad [QFN]

Dimension Limits	Units	MILLIMETERS		
		MIN	NOM	MAX
Number of Pins	N	64		
Pitch	e	0.50 BSC		
Overall Height	A	0.80	0.90	1.00
Standoff	A1	0.00	0.02	0.05
Contact Thickness	A3	0.20 REF		
Overall Width	E	9.00 BSC		
Exposed Pad Width	E2	5.30	5.40	5.50
Overall Length	D	9.00 BSC		
Exposed Pad Length	D2	5.30	5.40	5.50
Contact Width	b	0.20	0.25	0.30
Contact Length	L	0.30	0.40	0.50
Contact-to-Exposed Pad	K	0.20	-	-

- Pin 1 visual index feature may vary, but must be located within the hatched area.
- Package is saw singulated.
- Dimensioning and tolerancing per ASME Y14.5M.
  - BSC: Basic Dimension. Theoretically exact value shown without tolerances.
  - REF: Reference Dimension, usually without tolerance, for information purposes only.

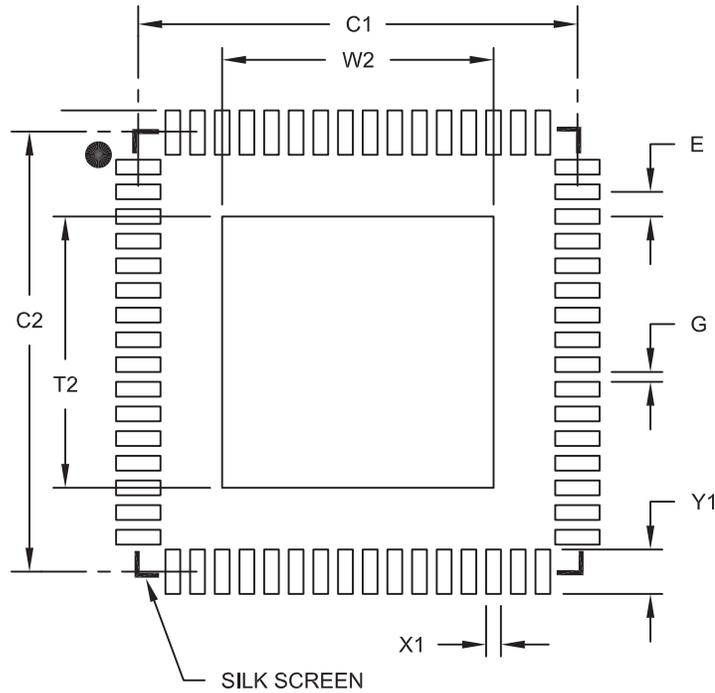
RECOMMENDED LAND PATTERN

64-Lead Plastic Quad Flat, No Lead Package (MR) – 9x9x0.9 mm Body [QFN]  
 With 0.40 mm Contact Length and 5.40x5.40mm Exposed Pad

Units	MILLIMETERS		
Dimension Limits			MIN	NOM	MAX
Contact Pitch	E		0.50 BSC		
Optional Center Pad Width	W2				5.50
Optional Center Pad Length	T2				5.50
Contact Pad Spacing	C1			8.90	
Contact Pad Spacing	C2			8.90	
Contact Pad Width (X64)	X1				0.30
Contact Pad Length (X64)	Y1				0.85
Distance Between Pads	G	0.20
